Complete transformation for the Cameron culverts

Egger, K., Alhussaini, H. and Baker, E.

Tunnels & Tunneling North America, May 2001

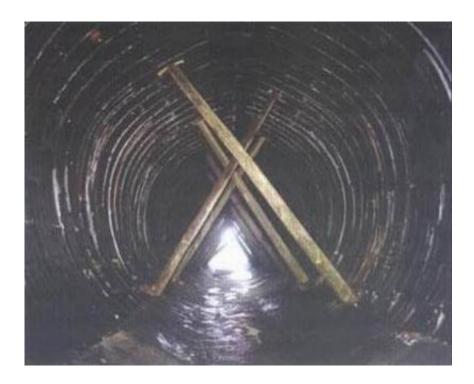
Figure 1: Props supported the liner plates of the old culverts.

After removing the existing invert concrete and remedial timber prop supports in the Cameron Run culverts, the sequence of operations involved installation of W6 x 20 steel sets inside the tunnels; reshaping of the deformed finer plates to accommodate the ovoid geometry; and application of 27.6 N/mm² (4,000psi) fiber-reinforced shotcrete to a minimum 160mm (6,25in) thickness.

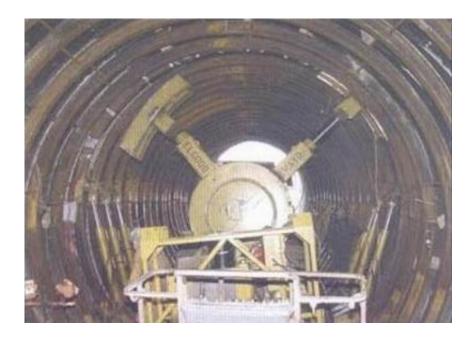
Figure 2: Expanded steel sets reshape the tunnel geometry.

After removing the old concrete invert, the steel sets were placed and blocked against the existing liner plates at 1 m (3ft) centers and mainly in deformed sections of the culverts, the sets were installed with temporary filler pieces replaced with longer pieces after expansion to the designed ovoid shape. The transition from pre-expanded to post-expanded sets was accomplished using filler pieces at the spring-line. An expander fabricated for Merco by Elgood Mayo, equipped with four 200 ton hydraulic jacks on two expansion arms and mounted on a loader, was used to install the steel arches and push back liner plates encroaching into the renovated tunnel profile. Metro expanded 230 steel sets in 64 shifts which results in a rate of 3,6 rings/shift, quite an achievement for such an innovative technique. Conditions such as the density of the surrounding material, the presence of grout in the soil, aril tale magnitude and type of deformation influenced the rate of expansion.

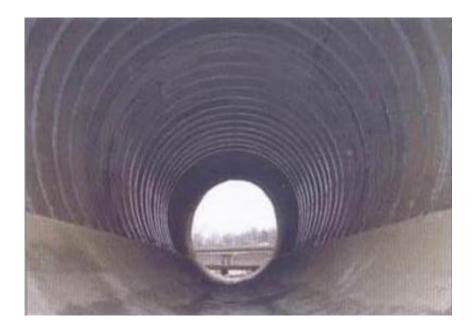
Figure 3: Repaired culverts relined with fiber-reinforced shotcrete.

The final wet-mix shotcrete lining contains 35kg/ m3 of Novocon Fortex steel fiber and is dosed with MBT Meyco SA 160 accelerator. The mix was field-tested extensively to confirm the required strength and, more importantly synchronize feed of the accelerator into the pumped volume of shotcrete. Shotcrete is being applied using a Reed primp ,with a maximum 24-stroke/h pumping capacity Water reducers keep the water-to-cement ratio at design value to maintain shotcrete strength. During severe cold weather, both portals of the shotcreted tunnel were sealed, and the tunnel heated to near 15°C: (59°F) Cores front the sprayed liner confirmed that 7-day and 28-day strengths met or exceeded requirements. Some 2,300m3 (3,000 yd3)of shotcrete has been applied to date. Shotcreting in each tunnel was kept at least two tunnel diameters behind the expanding activity in the adjacent tunnel to avoid disturbing the curing shotcrete.

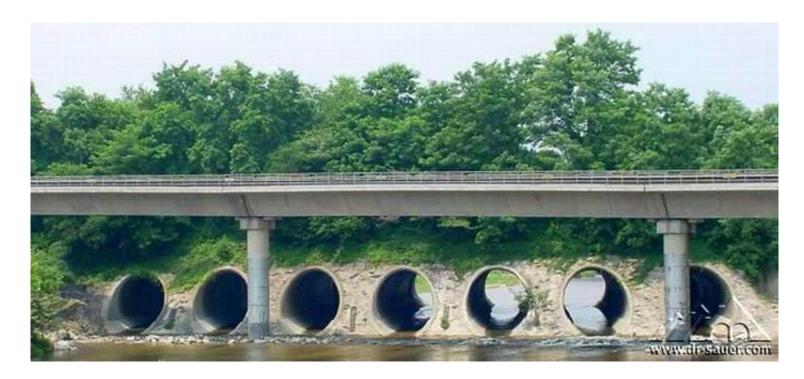
Figure 4: Finished Cameron Run culverts.

The original \$3.56 million 14-month contract was extended by two months and to \$3.8 million to complete additional work requested by the City of Alexandria. This was to improve the flow characteristics of the Cameron Run by placing concrete aprons and rip-rap at the tunnel portals. No other changes of any significance were required. Contingency items in the unit price contract are being mainly used to compensate Merco for unforeseen work and weather related delays. Although there is no partnering arrangement set-up between the owner, the construction management team and the contractor, the work is being executed in a cooperative way with frequent discussions between the involved parties to coordinate and solve technical, administrative and fiscal issue.
